**National Highway  
Traffic Safety  
Administration**

Case Vehicle (A): 1999 Volkswagen  
Type: Jetta, 4-door sedan  
Driver: 32-year-old male  
CDC: 06-BDEW-7, 01-FDEW-3

Vehicle (B): 1998 Dodge  
Type: Ram 1500, 4x4 pickup  
Driver: 27-year-old female  
CDC: 99-0000-0

Vehicle (C): 2001 Dodge  
Type: Dakota, 4x4 pickup  
Driver: 35-year-old female  
CDC: 99-0000-0

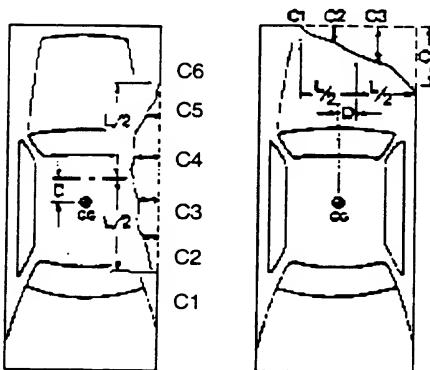
Specific Impact No.	Location of Direct Damage	Location of Field L
1	Begins(R) rear bumper corner	B.C. to B.C.
2	Begins(R) front bumper corner	B.C. to B.C.

DL 150  
UDL ①

Specific Impact Number	Plane of Impact C-Measur.	Direct Damage		Field L	C <sub>1</sub>	C <sub>2</sub>	C <sub>3</sub>	C <sub>4</sub>	C <sub>5</sub>	C <sub>6</sub>	±D
		Length (DDL)	Max Crush								
1	Bumper 151	C2	139	90	92	75	73	59	55	0	
	- Freespace				-8	-1	0	0	-1	-8	
1	1	151	091	139	082	091	075	073	058	047	+000
13	14	15 16 17	18 19 20	21 22 23	24 25 26	27 28 29	30 31 32	33 34 35	36 37 38	39 40 41	42 43 44 45
2	Bumper	152	C3	142	51	40	46	30	21	25	+000
	- Freespace				-12	-2	1	1	-2	-12	
2	1	152	045	142	39	38	45	29	19	13	+000

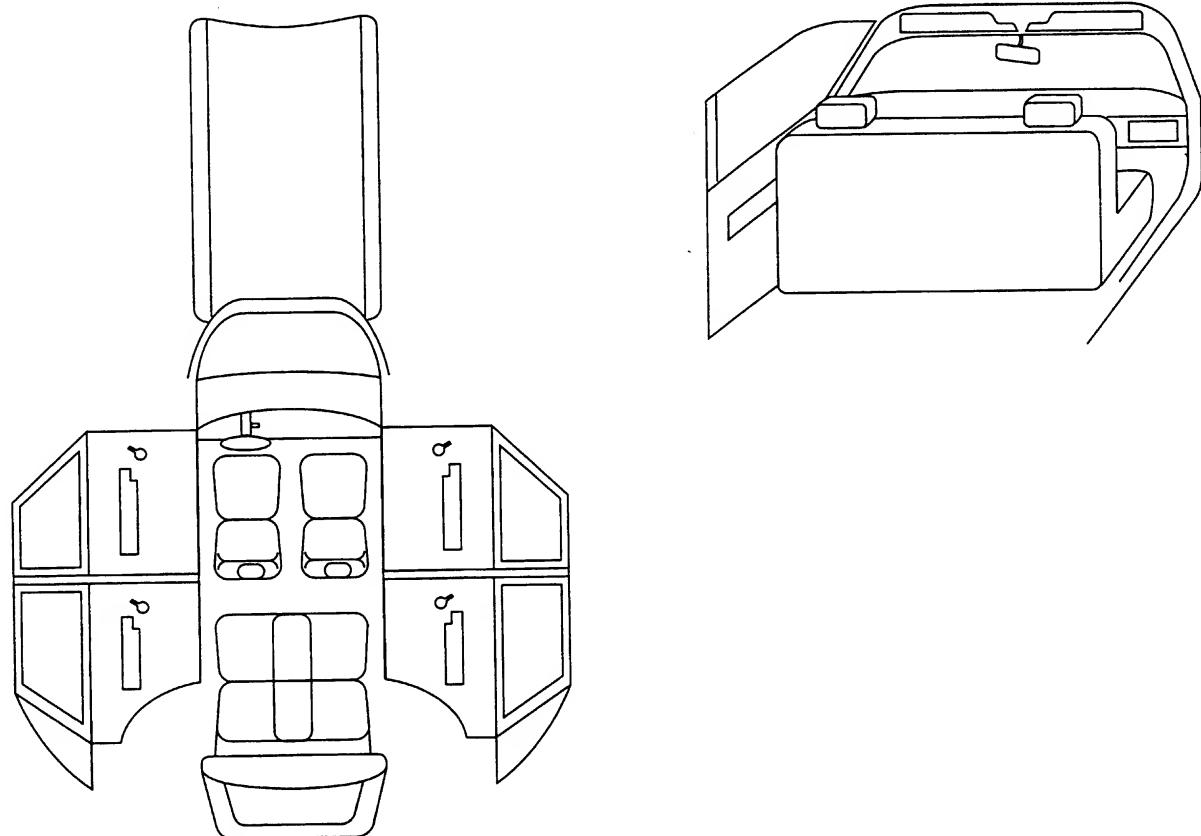
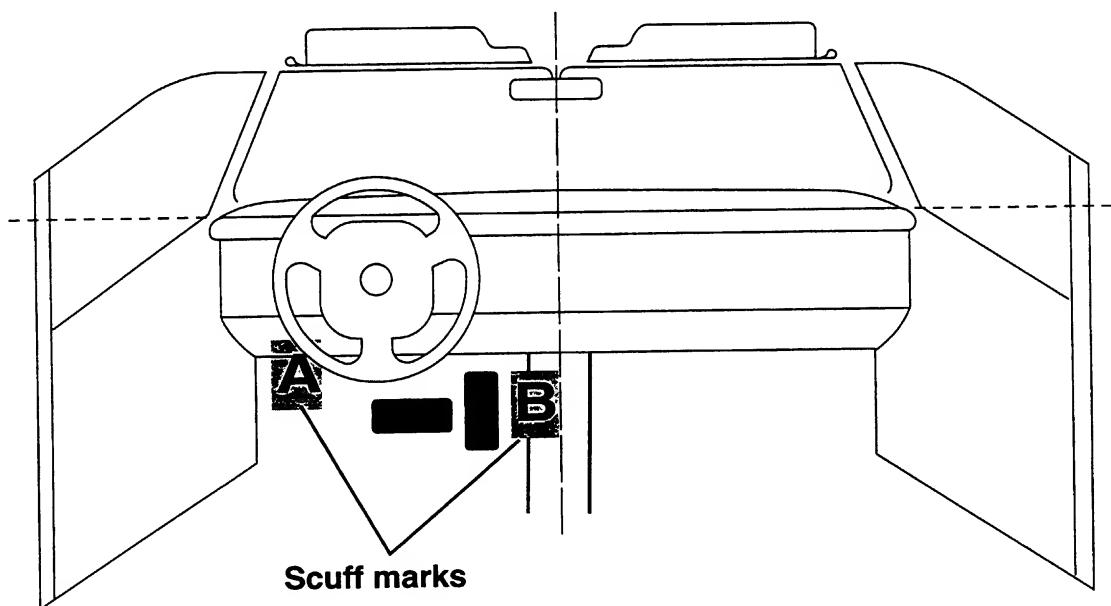
Contact	Interior Component Contacted	Occupant No. if Known	Body Region if Known	Supporting Physical Evidence	Confidence Level of Contact Point
A	Knee bolster	1	Knee	Scuff mark	1
B	Knee bolster	1	Knee	Scuff mark	1
C					
D					
E					
F					
G					
H					
I					
J					
K

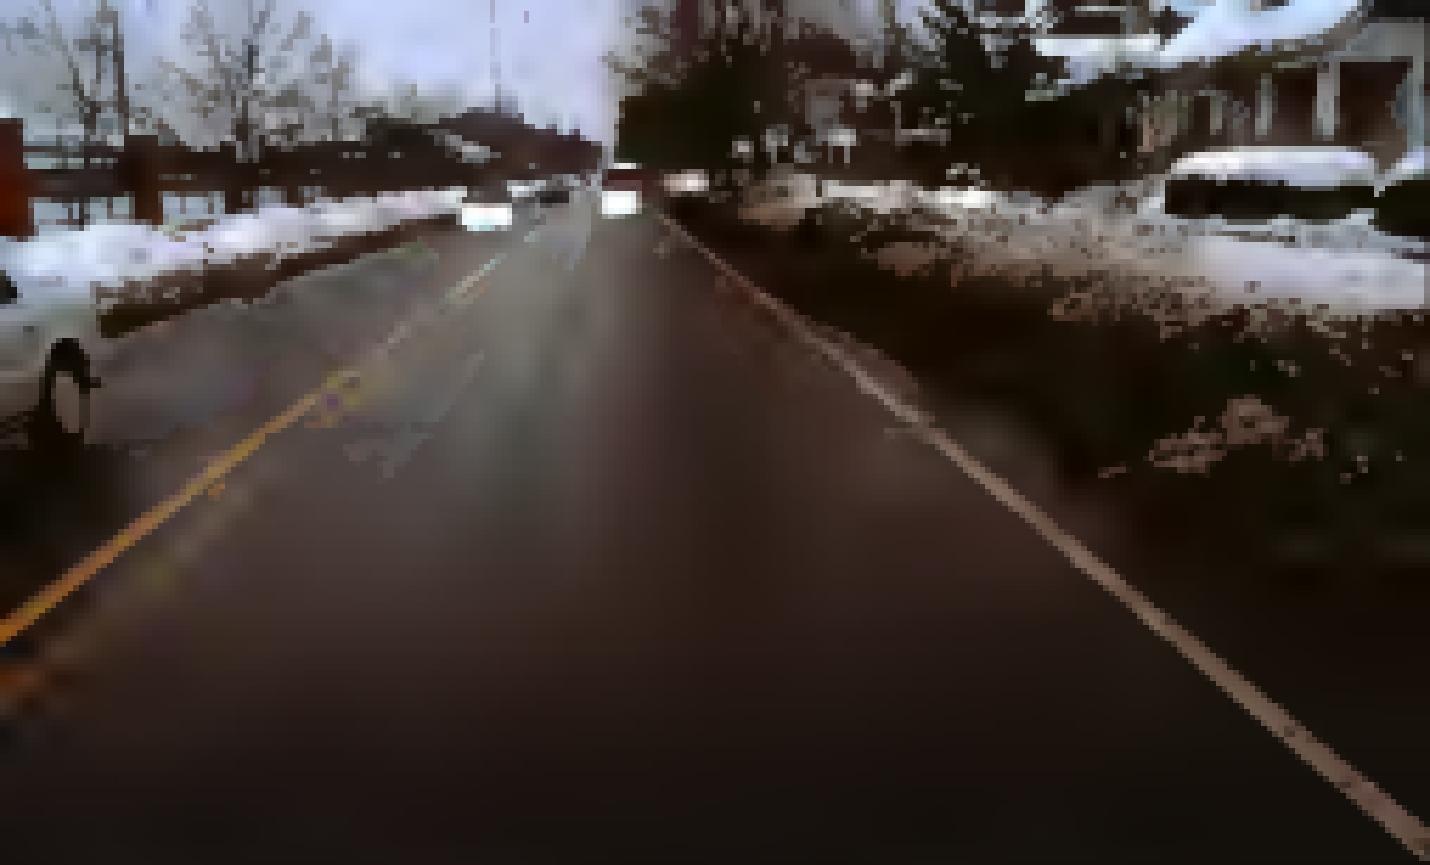
PH 22700 #1

(Slide 1) Case vehicle (A) was traveling north in the northbound lane of a straight section of a dry, asphalt, two-lane roadway, (slide 2) with a speed limit of 48 kph (30 mph). Vehicle (B) was traveling south in the southbound lane of the same roadway. Vehicle (C) was traveling north in the same northbound lane, behind case vehicle (A). Vehicle (C) struck the rear of case vehicle (A) and caused case vehicle (A) to veer sharply to the left, cross the centerline, and enter the path of vehicle (B). The driver of case vehicle (A) reportedly attempted to avoid a collision with vehicle (B) by veering to the right and braking, but case vehicle (A) struck the front of vehicle (B) with its front.

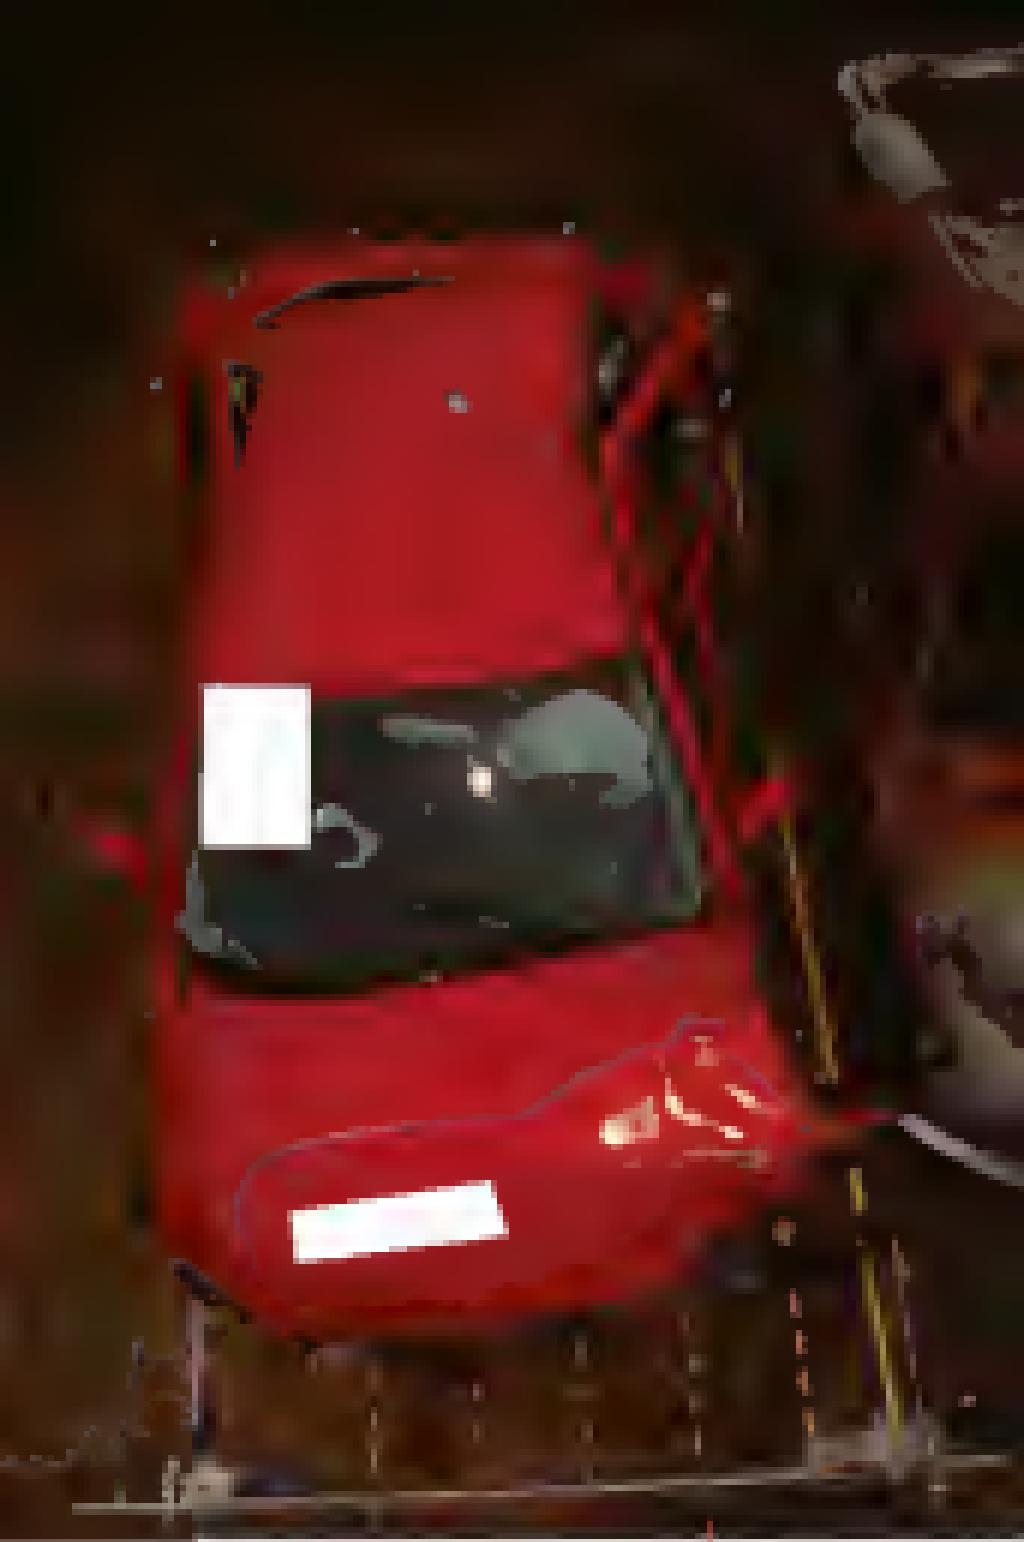
PN 22700 #3

(Slide 3) Damage to case vehicle (A) was severe. The direct-damage length for the rear impact was 151 cm and extended across the entire rear of the vehicle. The maximum crush was 91 cm and occurred 28-cm inboard from the left-front bumper corner. The direct-damage length for the frontal impact was 152 cm, and extended across the entire front of the vehicle. The maximum crush was 45 cm and occurred 56-cm inboard from the left-front bumper corner. The left wheelbase was reduced 16 cm, and the right wheelbase was reduced 8 cm.

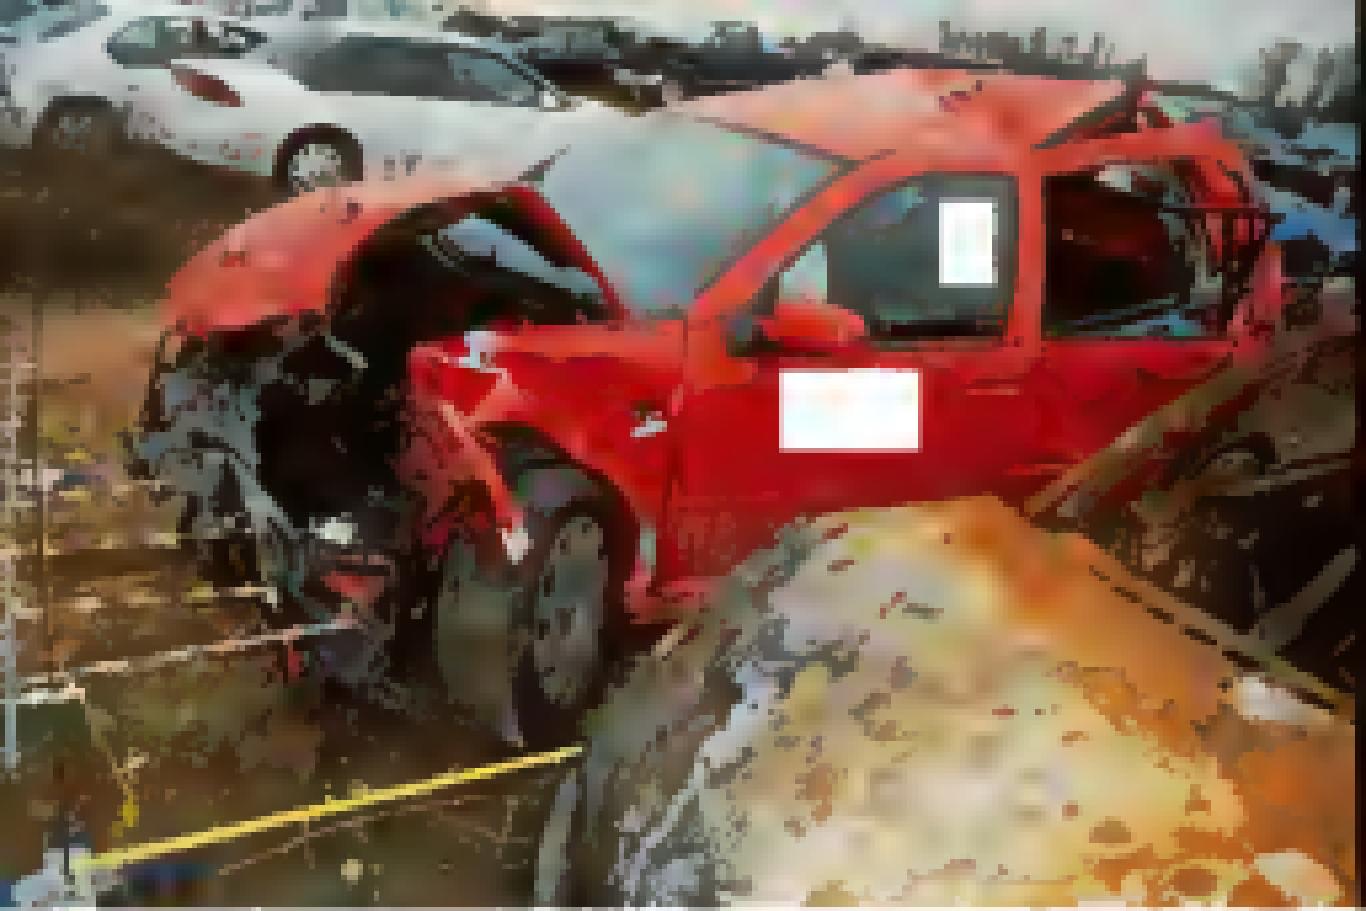
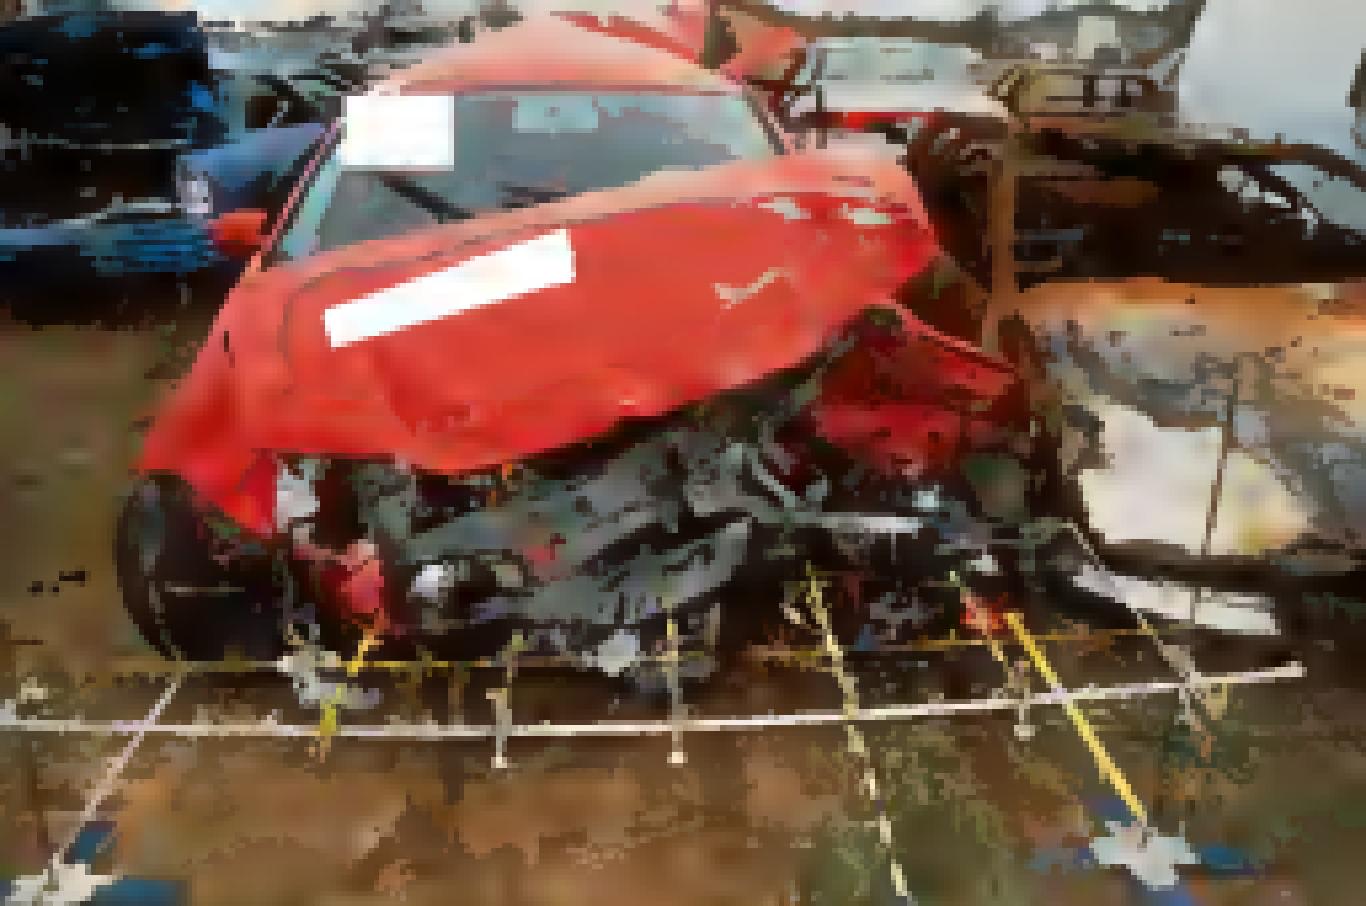
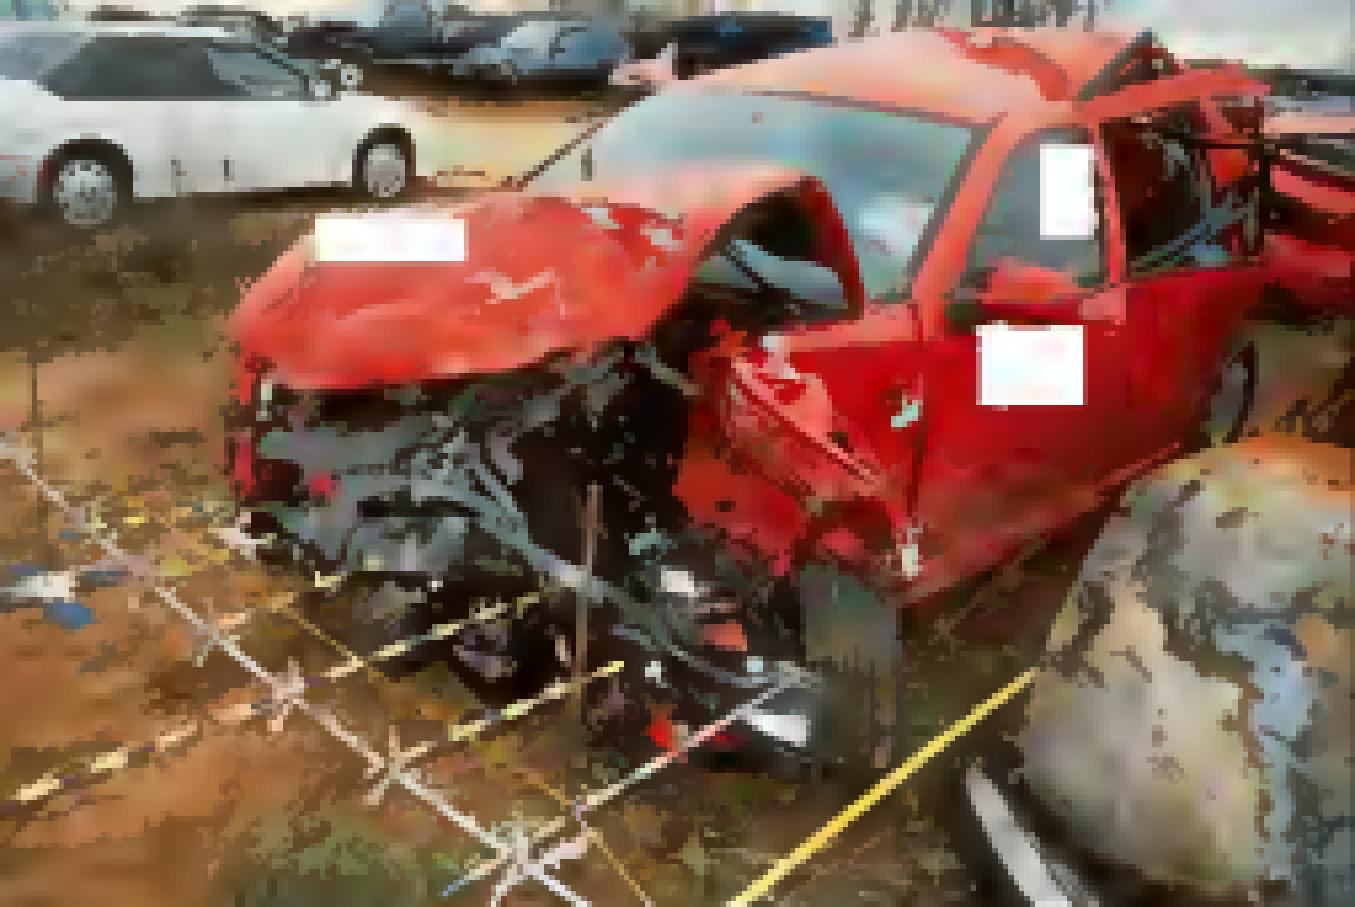
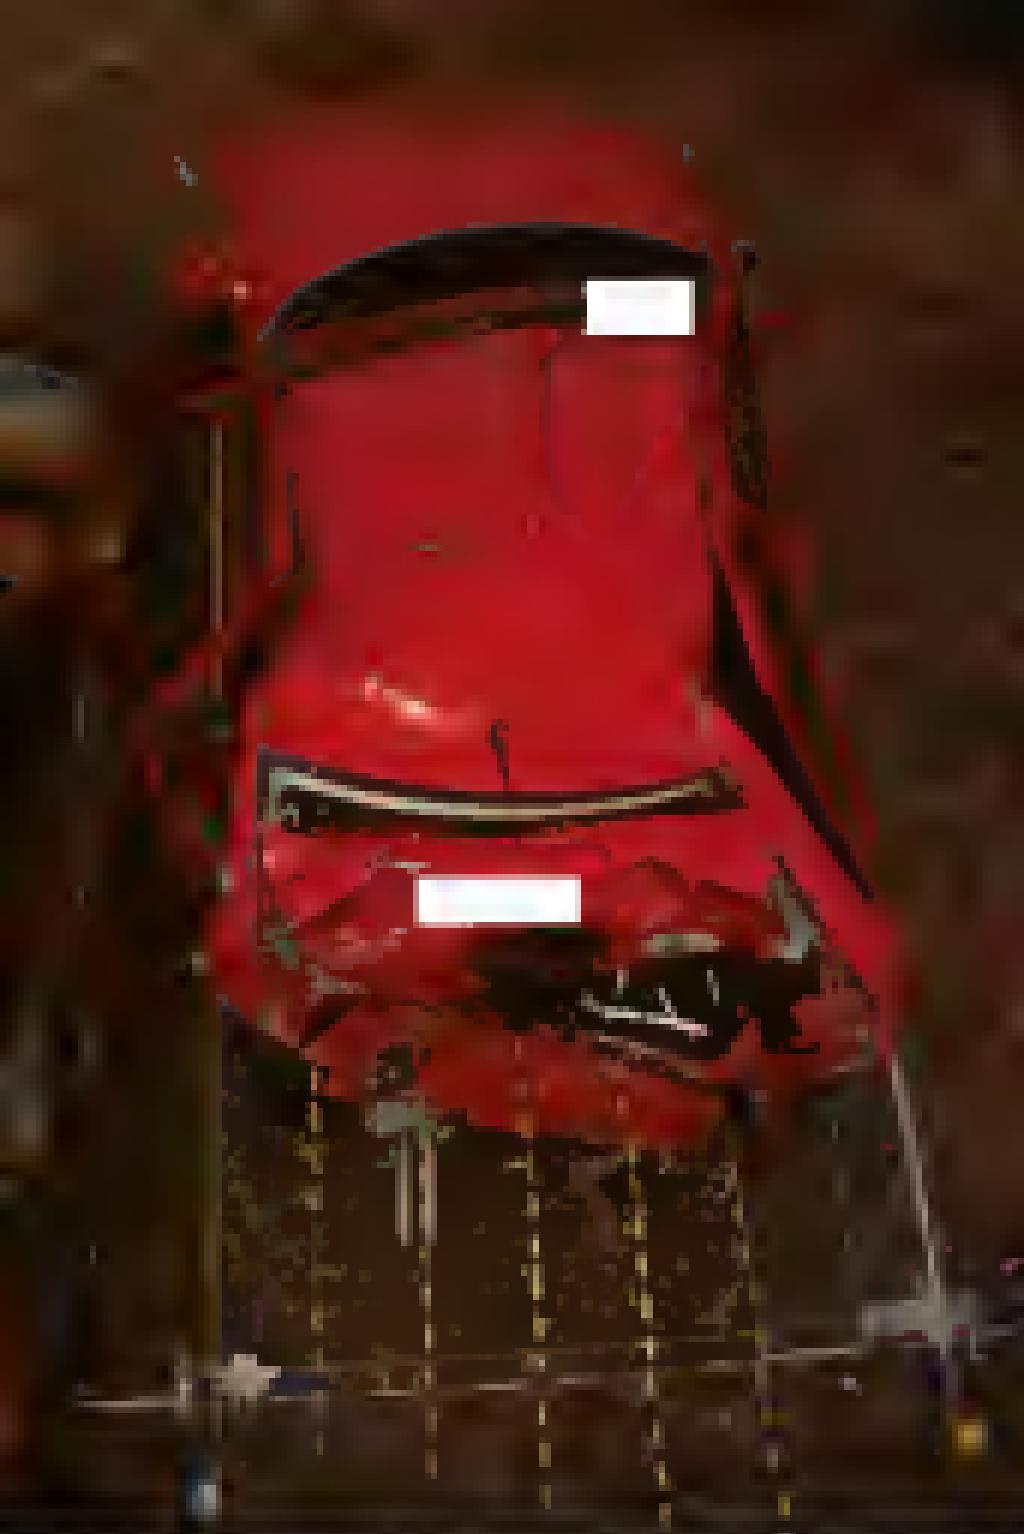
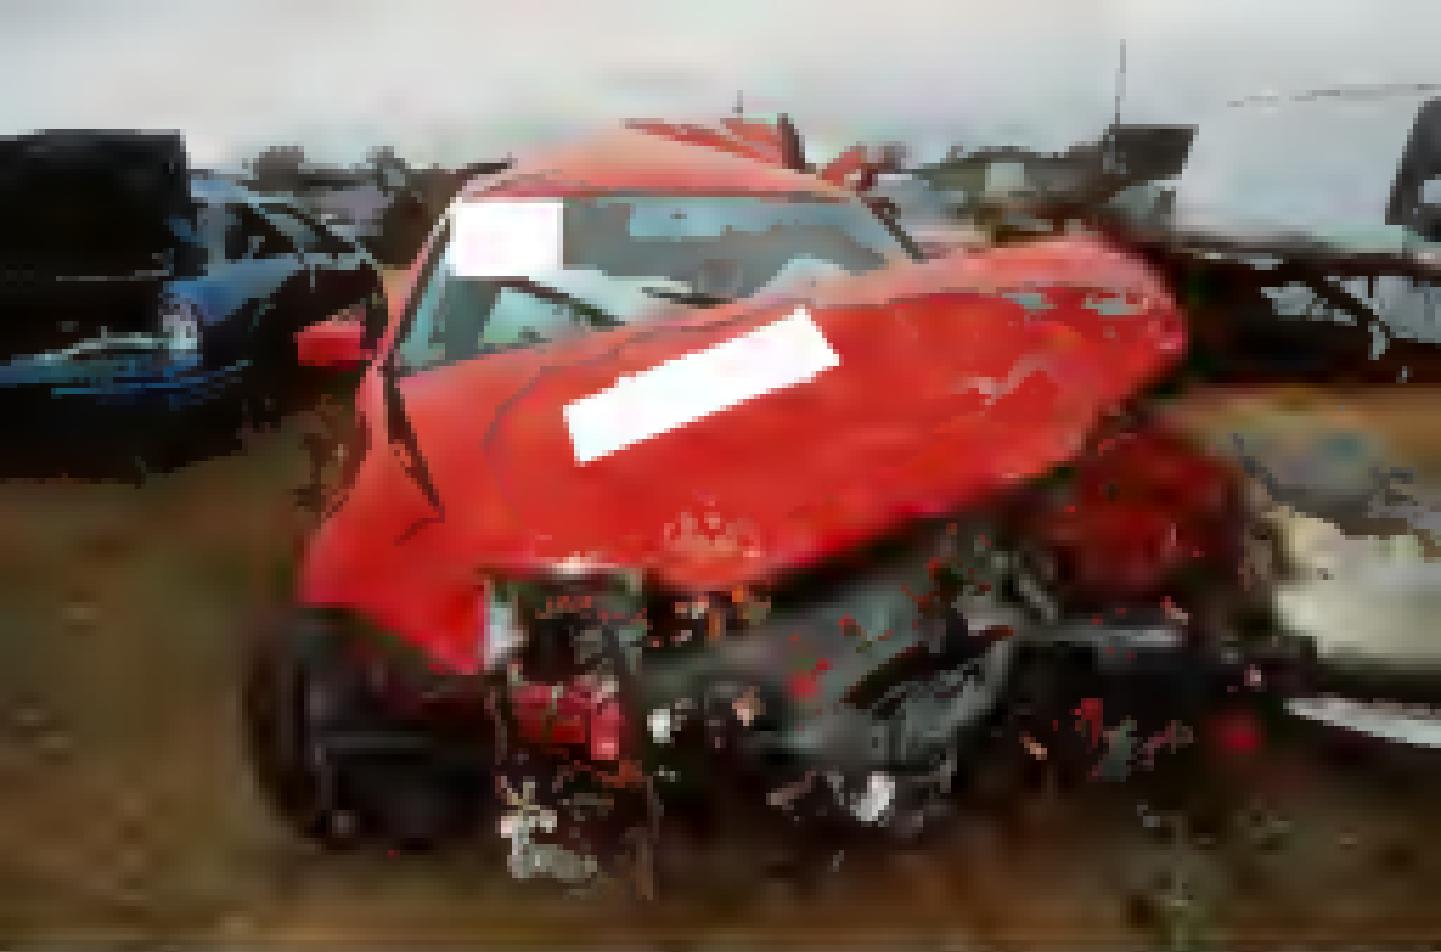
Using the WinSMASH accident-reconstruction program and (slides 4, 5, 6, 7, 8) c-values for case vehicle (A), the following impact severities were calculated:

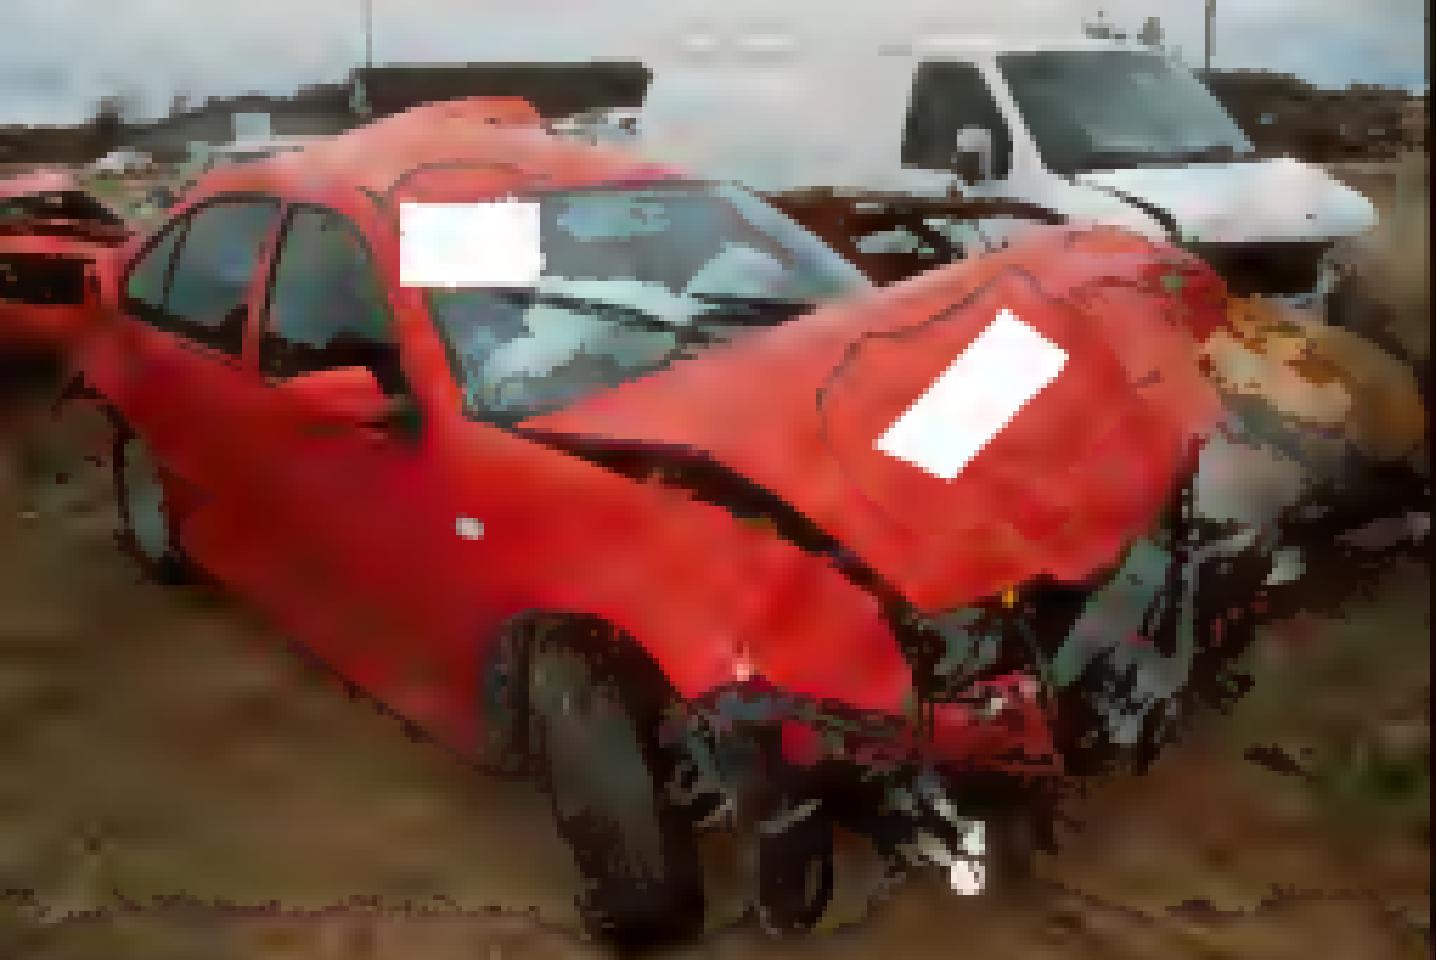
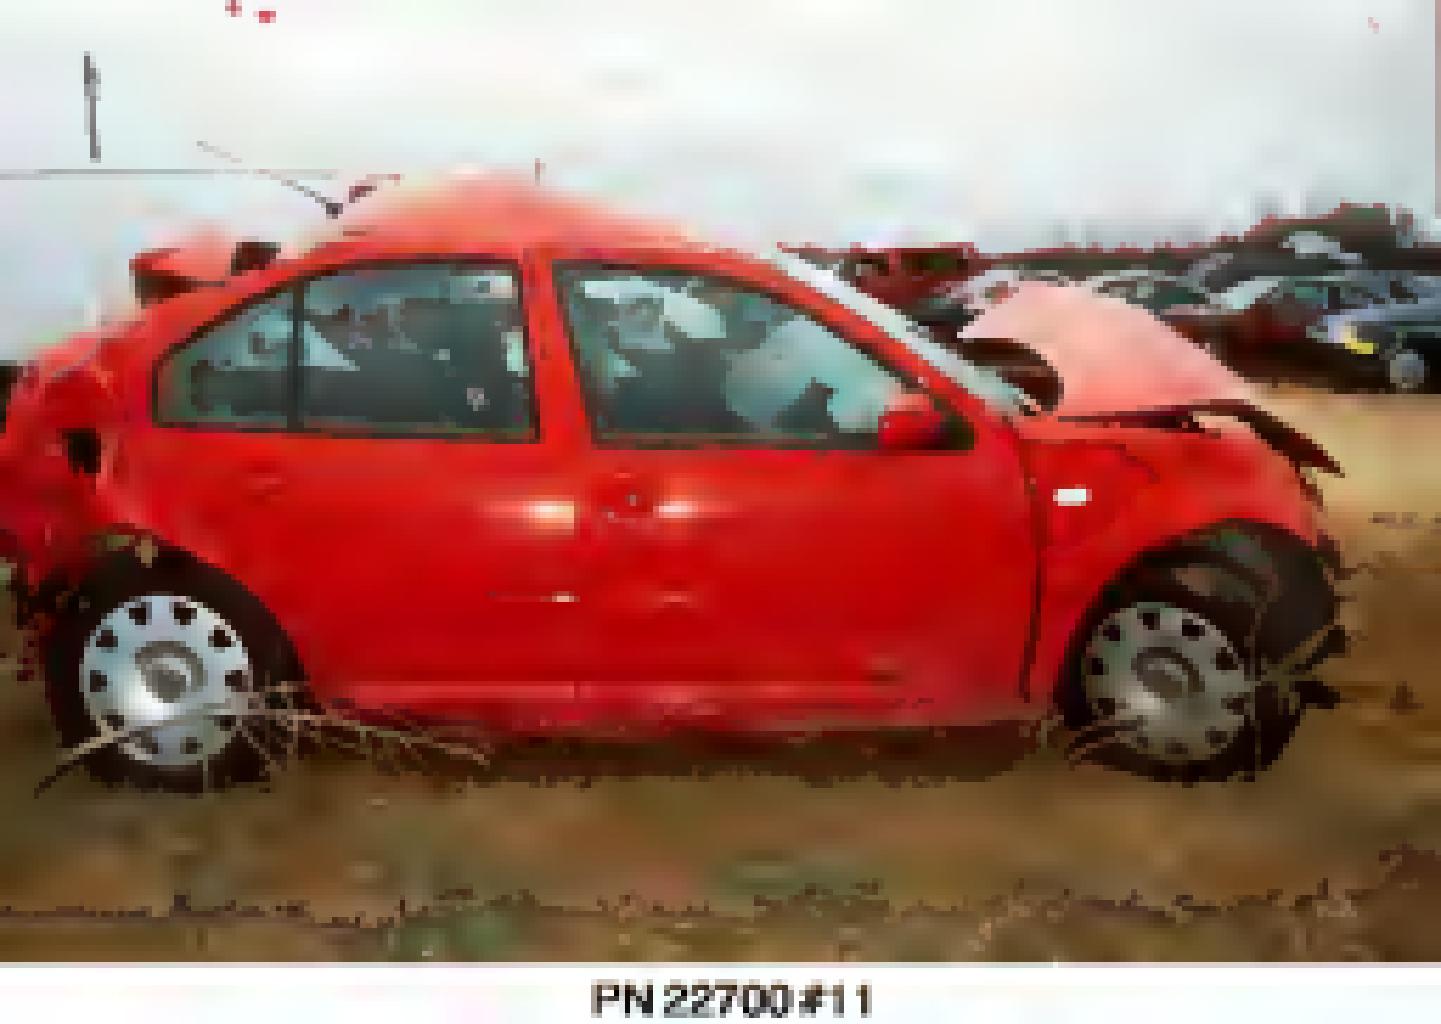
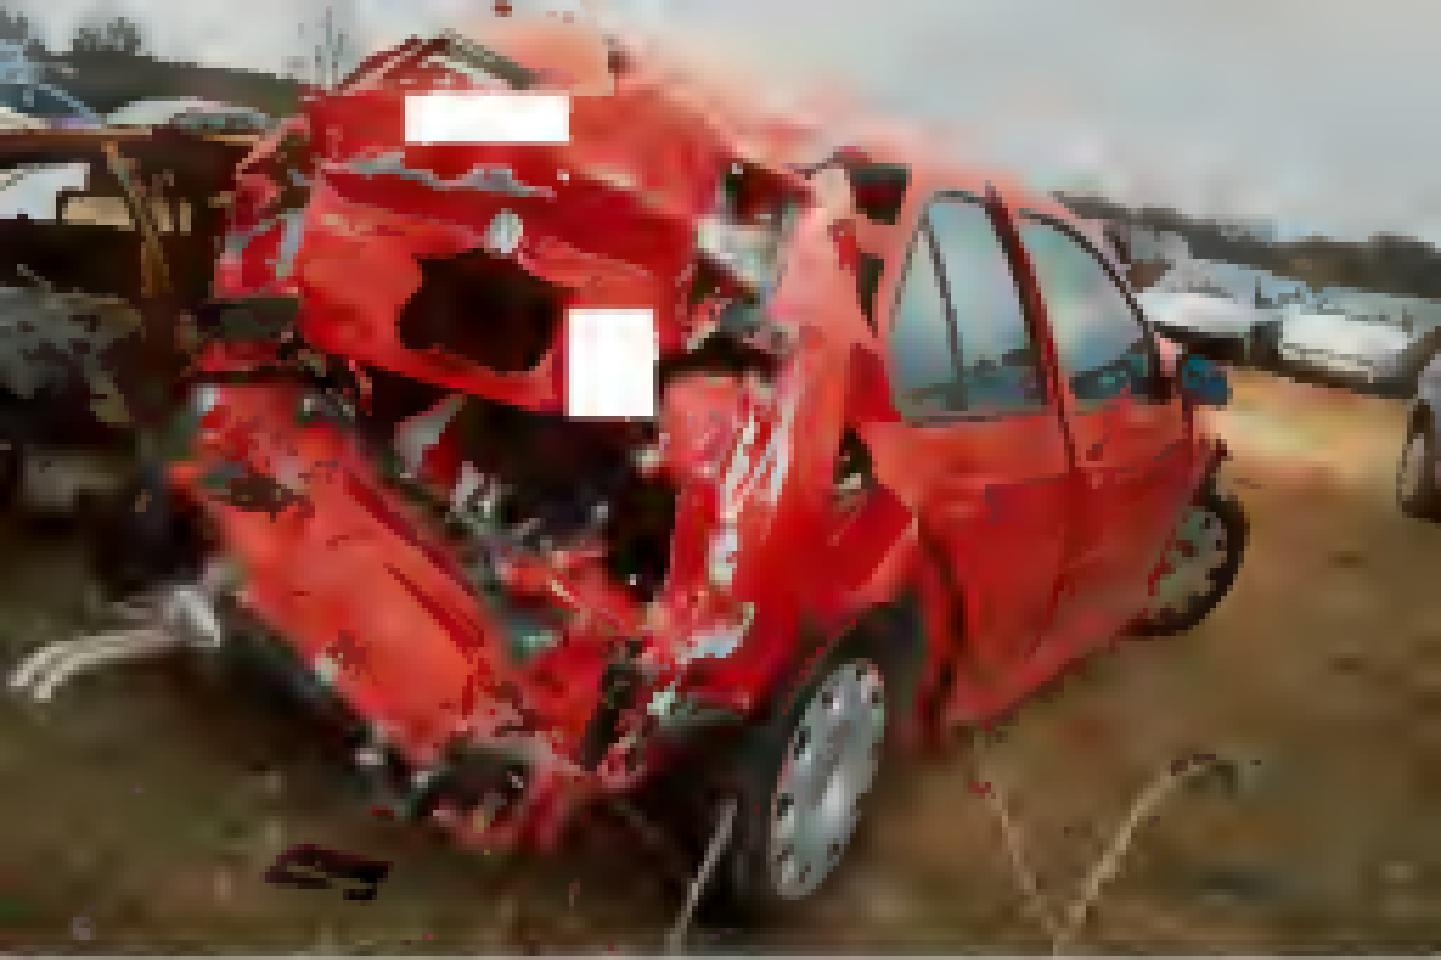
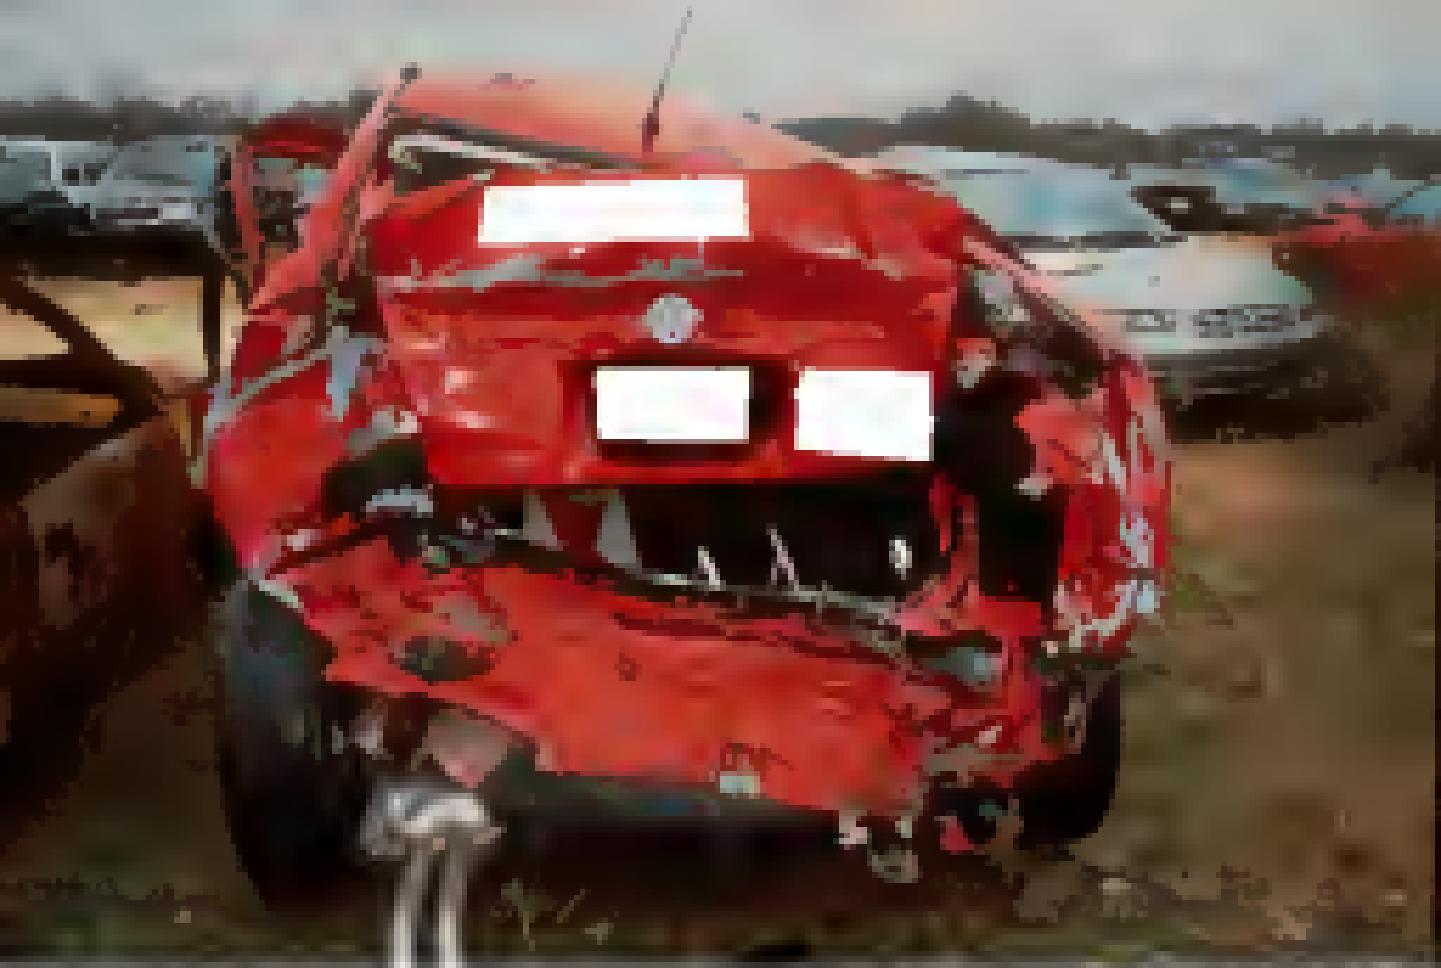
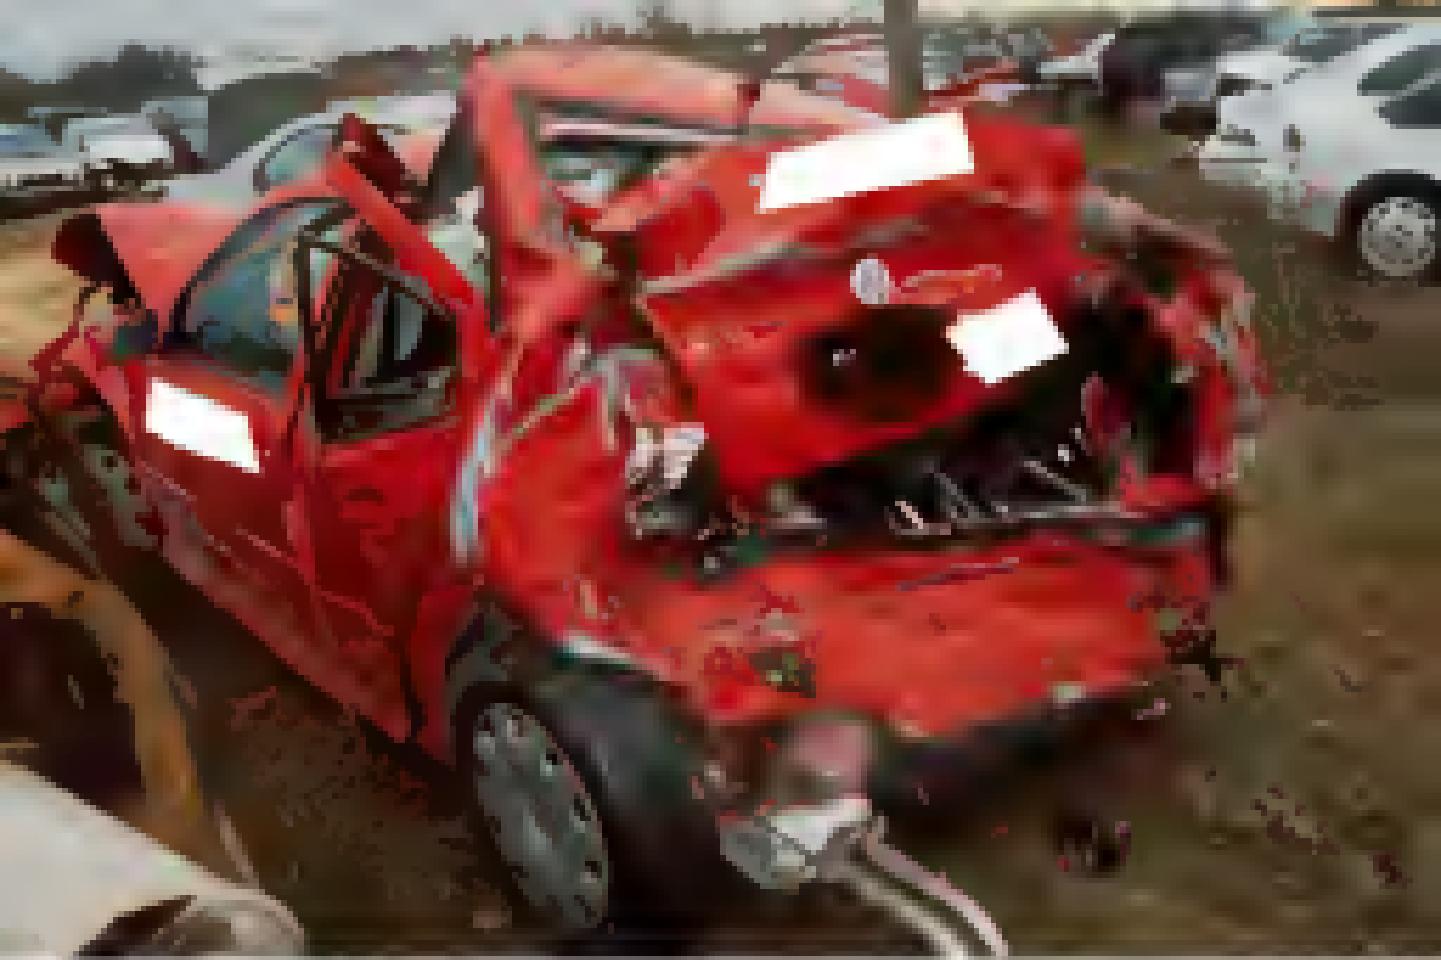
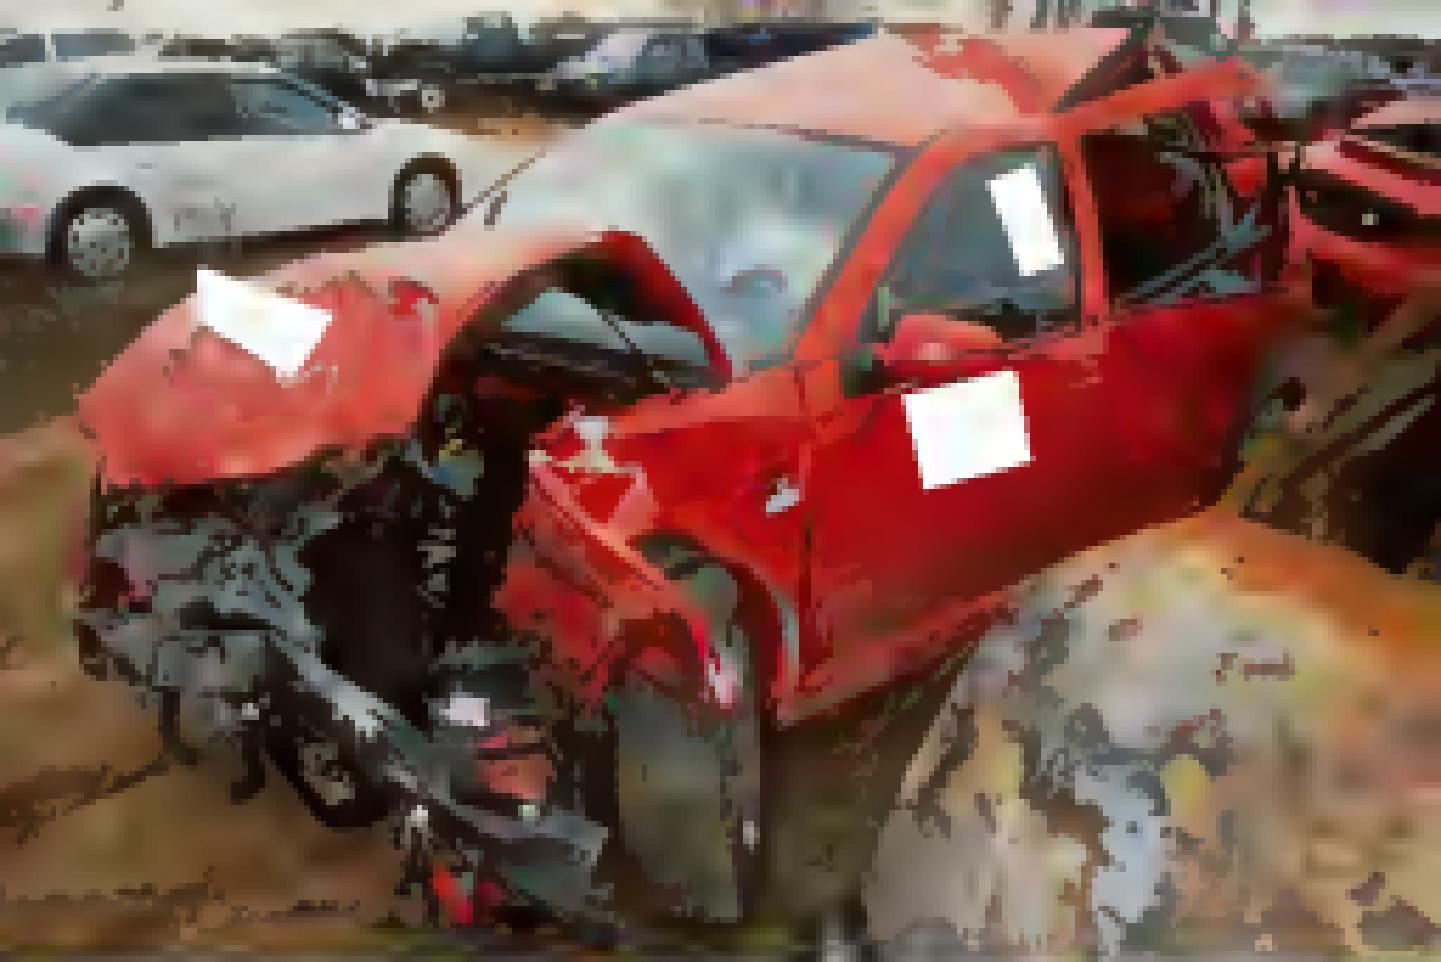
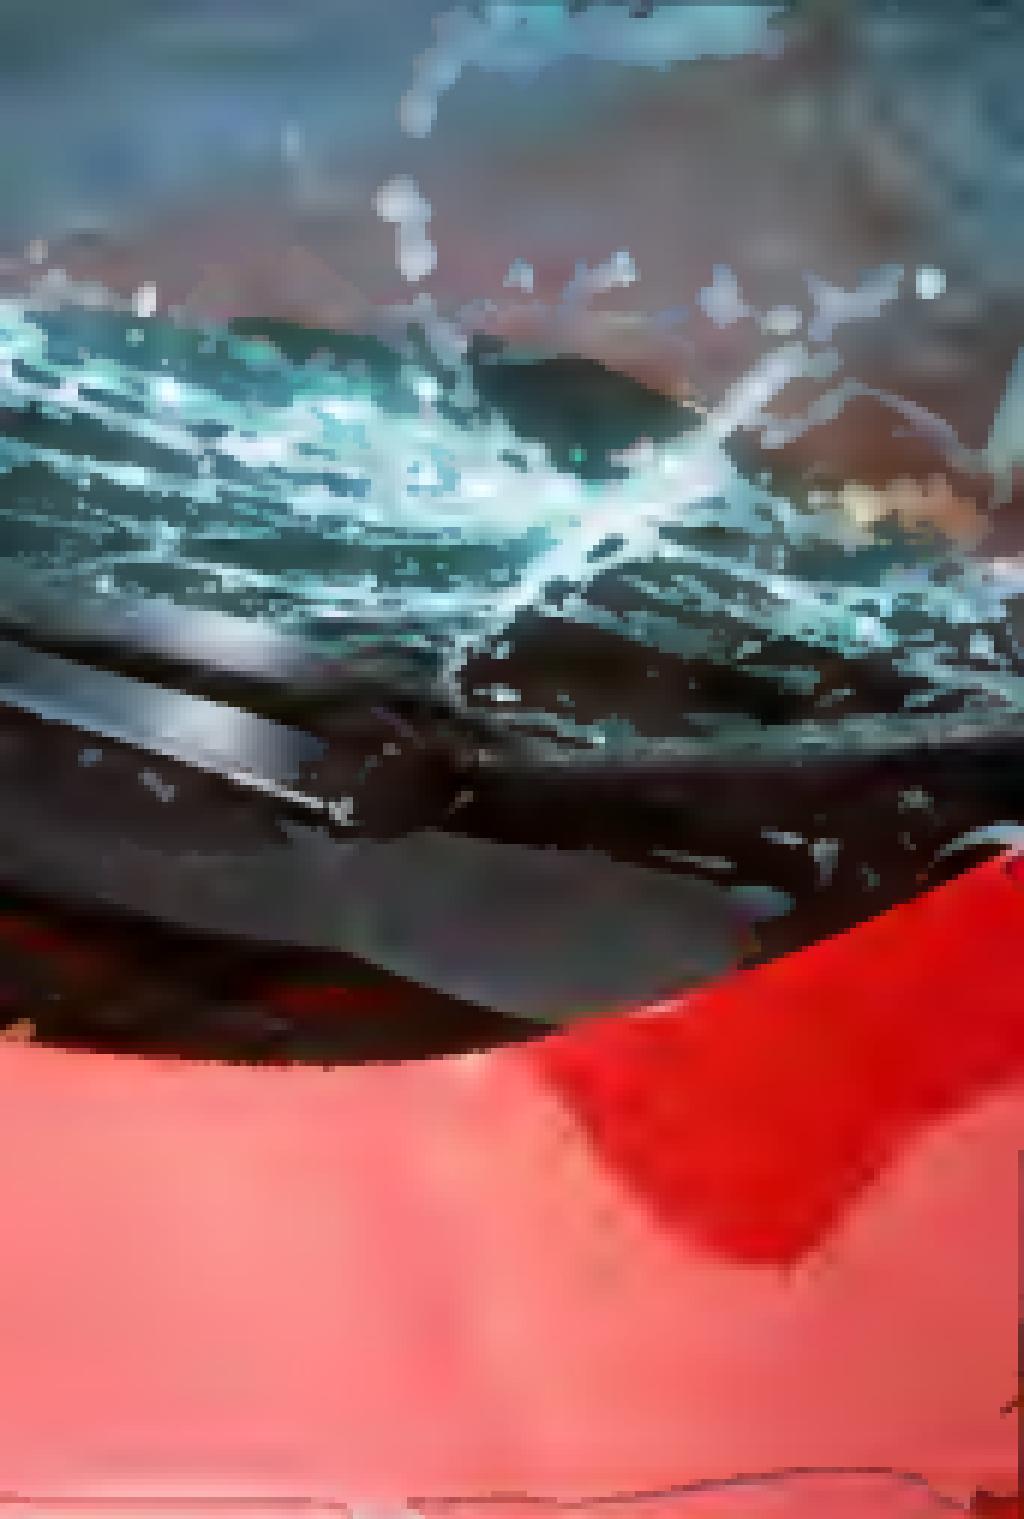
(Slides 9, 10, 11, 12, 13, 14, 15) The front bumper, both headlight assemblies, the grille, and the radiator were severely crushed from the impact with vehicle (B). (Slide 16) The hood was crushed and elevated and contacted the windshield, but did not penetrate it. (Slides 17, 18) The hood latch was damaged and released. Both hood hinges were damaged. The windshield was cracked by the stress of impact forces. The right fender was buckled and the left fender was severely buckled. Both front doors remained closed and operational. Both rear doors were jammed shut. All of the wheel struts were damaged. Both quarter-panels were severely buckled. The roof was buckled and the left upper A-pillar was deformed, as a result of the deformation of both of the C-pillars and both rear roof siderails. The back bumper, both taillight assemblies and the trunk lid were severely crushed from the rear impact by vehicle (C).
